**Volare**Airlines

<b>ENGINEERING SCRIPT</b>	<b>Date 04/09/2004</b>	
	<b>Page 1 of 7</b>	
	<b>Ref:</b> ES-N0661	
	<b>Ext:</b> 51-EE0318

<b>SUBJECT:</b>	A320 MSN 446 I-PEKR: Hail Strike Damage Report
<b>A</b>	<b>Effectivity:</b> MSN 446
<b>B</b>	<p><b>Reference:</b> Air Europe Damage Report dated 04/09/2004 Pictures</p> <p><b>Background:</b> On date 03/09/2004, during Flight VLC-MXP a heavy Hail Strike has been reported by a/c A320 MSN 446 I-PEKR. The following damages have been reported:</p> <ul style="list-style-type: none"> <li>- Radome completely damaged (Ref to picture attached)</li> <li>- Weather Antenna damaged</li> <li>- LH &amp; RH Windshields outer panes broken</li> <li>- Several Dents reported on the Nose Skin Panels SRM 53-11-11 Figure 1 Items 1, 5, 15, 20, 25; Figure 5 Item 1</li> <li>- All Slats from 1 to 5 LH &amp; RH are affected from dents (Ref to Damage Report attached)</li> <li>- Engine #1 Air Intake has reported one important dents (Ref. "A" in Damage Report page 1 attached) and some minor dents (Ref to Damage Report attached)</li> <li>- Engine #2 Air Intake has reported some minor dents (Ref to Damage Report attached)</li> <li>- Horizontal Stabilizers LH &amp;

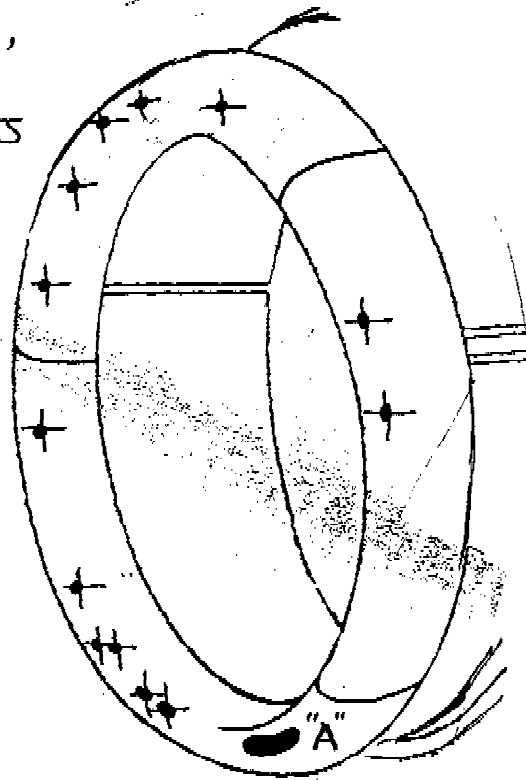
NOSE COWL N° 1

"A" = ONE ELLIPTICAL SHAPED DENT, 75 MILLIMETRES LENGTH, 6 MILLIMETRES DEEP, LOCATED AT 5 O'CLOCK, 150 MILLIMETRES BELOW LIP SEGMENT END. DENT LOCATED "OUTSIDE"

OTHER DENTS IDENTIFIED AS +, ALL LOCATED ON LEADING EDGE, WITH AN AVERAGE DEPTH OF 2 MILLIMETRES, ELLIPTICAL SHAPED, WITH A LENGTH OF 25 MILLIMETRES (LONGER AXIS).

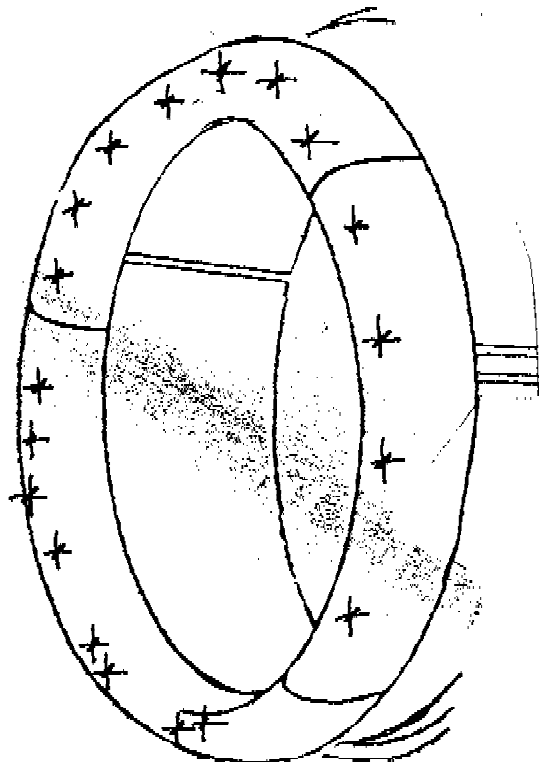
NOSE COWL N° 2 :

20 DENTS EQUALLY SPACED, AND LOCATED ON LEADING EDGE LINE ELLIPTICALLY SHAPED, WITH THEIR MAJOR AXIS OF 25 MM AND A DEPTH OF 1,0 MM

NOTE : ON BOTH INLET COWLS NO CRACKS OBSERVED AS A RESULT OF A CLOSE VISUAL INSPECTION OF ALL DENTS.

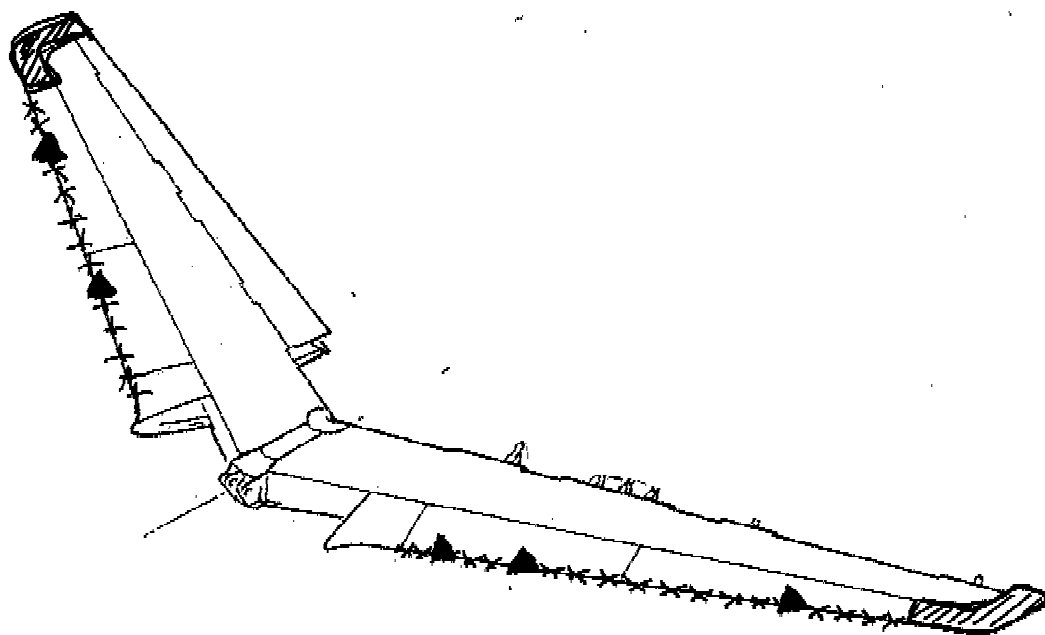
HORIZONTAL STABILIZER :

▲ PRE-EXISTING RECORDED DAMAGES  
WITHIN LIMITS OF SRM SS-12-00.

▨ BOTH STABILIZER TIP FAIRINGS CRUSHED

~~XXXX~~ STABILIZER LEADING EDGES DENTED.  
AFFECTING 100 % OF STABILIZER SPAN.  
DAMAGE EVIDENCED AS A "ROUGHNESS"  
MAXIMUM DEPTH OF DAMAGE NOT DEEPER  
THAN 4 MILLIMETRES.

NO DAMAGES OBSERVED ON STABILIZER BOX, NOR  
ELEVATOR SURFACES.

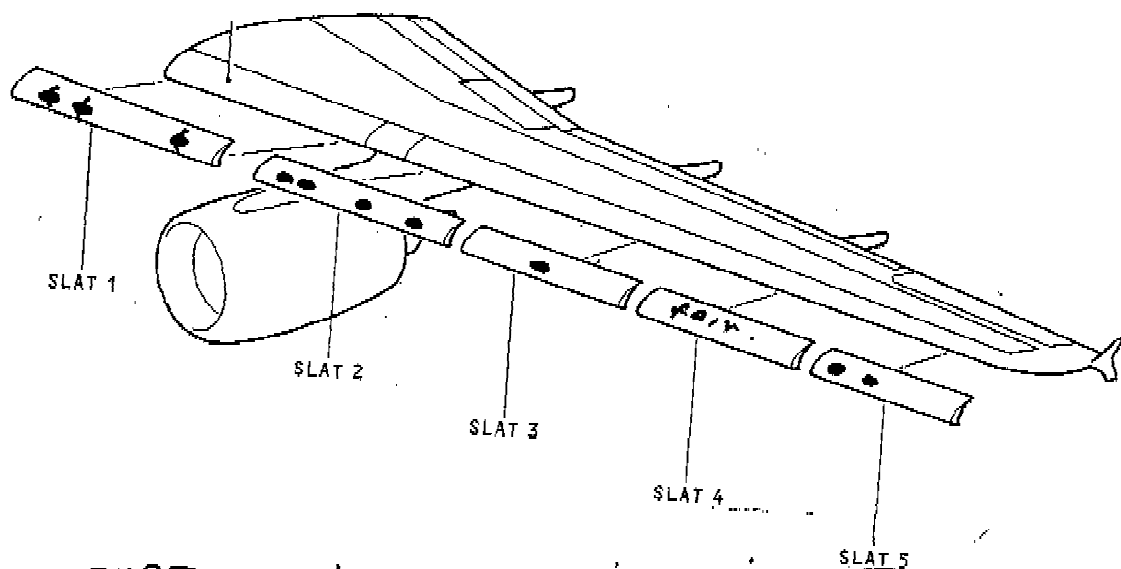
SLAT DAMAGES LH WING.

- SLAT 1 : THREE MAIN DENTS IDENTIFIED AS 4  
DENTS ELLIPTICAL. APPROX LENGTH 75 MM  
AND 5 MM DEPTH. OUTBD DENT WAS A  
PREEXISTING BIRD STRIKE WITHIN LIMITS, BUT  
SCHEDULED FOR A DEFINITIVE REPAIR WITHIN 9500  
FLT. CYCLES. MANY OTHER MINOR DENTS COVERING  
80% OF THE BULLNOSE SURFACE.
- SLAT 2 : 4 DENTS ELLIPTICAL 75MM DEPTH - 5MM.
- SLAT 3 : 1 DENT SAME AS SLAT 2.
- SLAT 4 : FAIR, ONLY SLIGHT DAMAGE.
- SLAT 5 : TWO DENTS 75 MM, 4 MILLIMETRES DEPTH.

NOTE: ALL DENTS ON AREA ③  
AS DEPICTED ON SRM  
57-40-00, FIGURE 107.

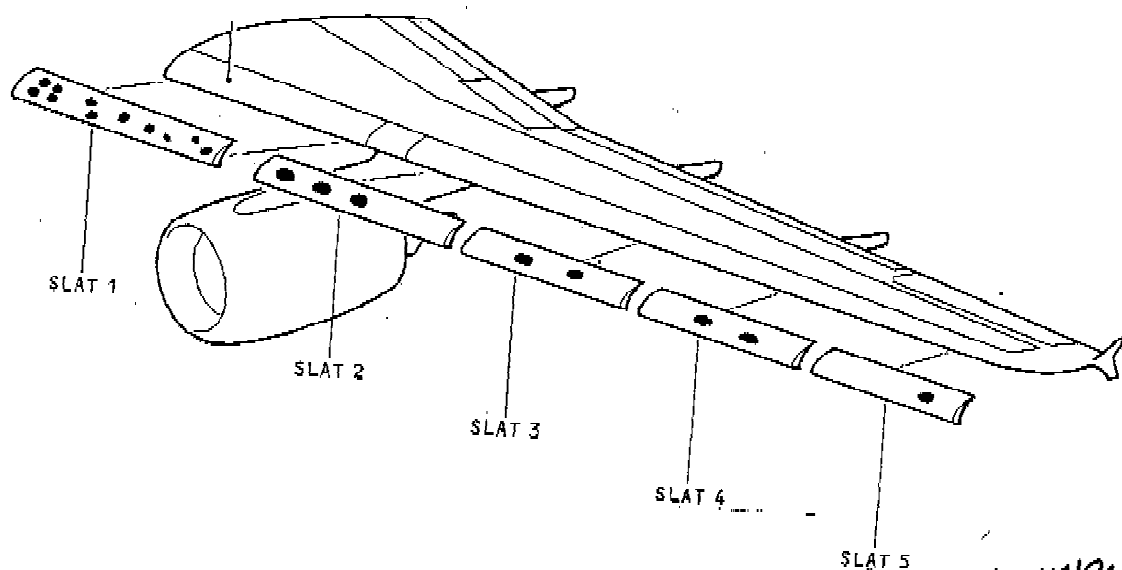
SLAT DAMAGES RH WING

SLAT 1: 80% OF THE SURFACE DENTED. TYPICAL DENT 25 MM IN DIAMETER BY 2 MM DEPTH. DENTS ON AREA ② & ③ AS SRM 57-40-00 FIG 107.

SLATS 2, 3, 4 & 5: DENTS AS SHOWN, APPROXIMATE 2,5 MM LENGTH & 5 MM DEPTH.

ALL SLATS WITH OVERALL DAMAGE, NOT DEEP (< 1 MM).

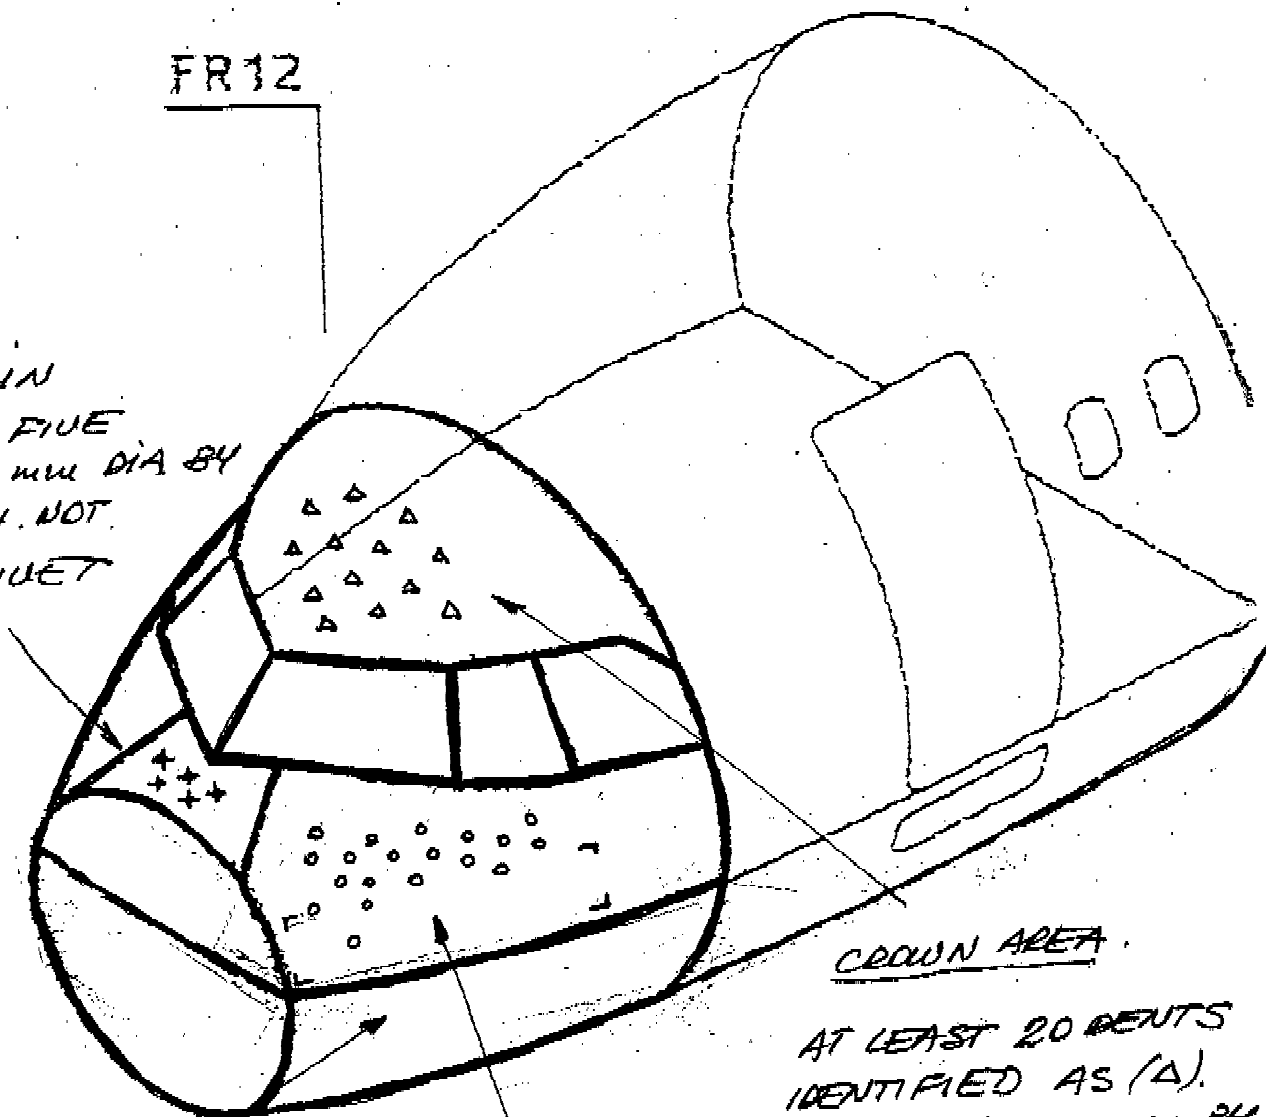
FRONT FUSELAGE SKINS

FRONT SKIN  
AT LEAST FIVE  
DENTS (Δ) 25 MM DIA BY  
1 MM DEPTH. NOT  
CROSSING RIVET  
LINES

AT LEAST 20 DENTS  
IDENTIFIED AS (Δ).  
APPROX. DIA 25 MM BY  
1 MM. DEPTH. NOT  
CROSSING RIVET  
LINES.

10 DENTS ONLY ON THE  
RIGHT SIDE, 25 MM DIA  
BY 1 MM DEPTH.

- ON THE LEFT SIDE, 21 DENTS (○)  
NOT AFFECTING RIVET LINES, AND  
WITH AN AVG. DIAMETER OF 25 MM  
AND 1 MM DEPTH. SOME DENTS  
ENTERING RUSM MARKS, AND  
ONE ON STATIC FIELD.
- SAME ON THE RIGHT SIDE,
